S-354  
William Martin House  
Princess Anne vicinity  
private

# Maryland Historical Trust State Historic Sites Inventory Form

Survey No. S-354

historic William Martin House

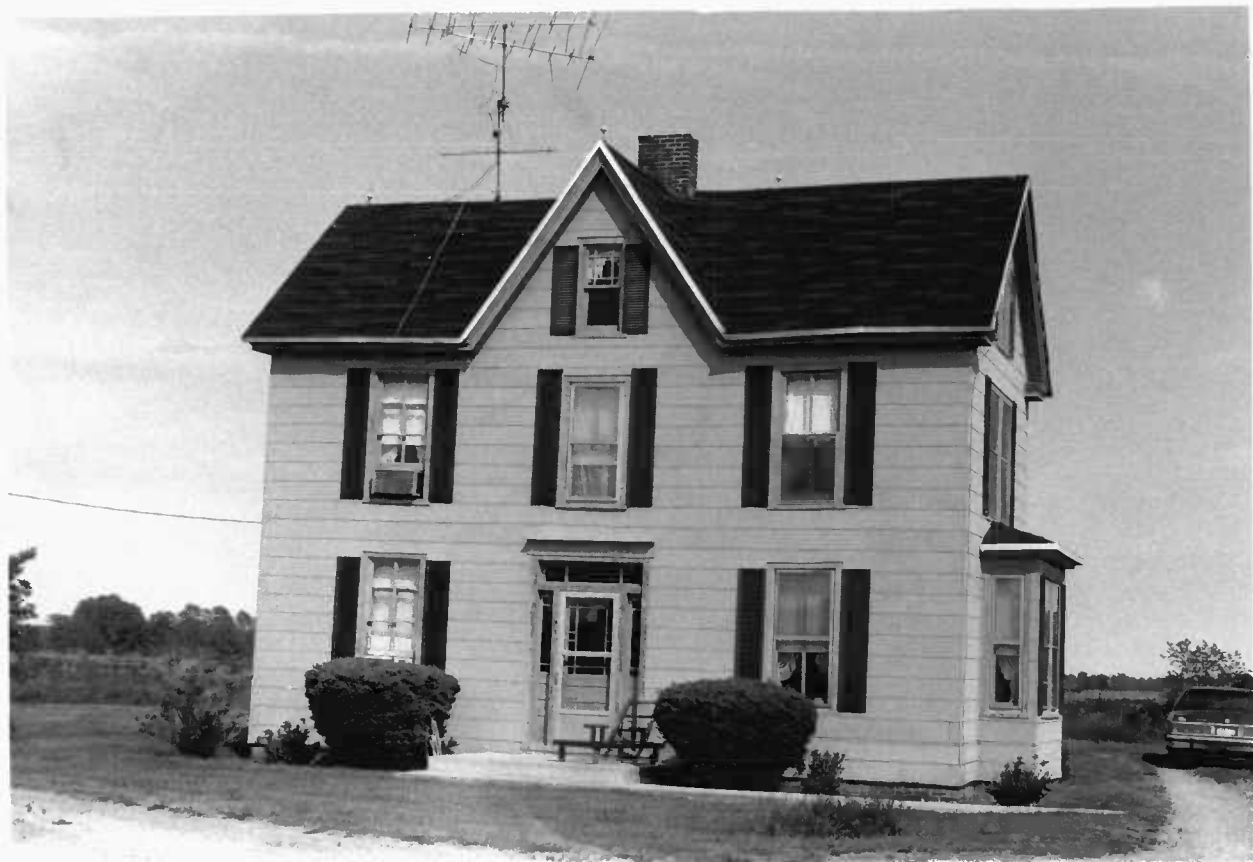
West Elevation

The west (front) elevation is a symmetrical three-bay facade with a center entrance and flanking ~~two-over-two~~ sash windows. The partially glazed front door is framed by side-lights and a transom. Lighting the second floor are three evenly spaced two-over-two sash windows, and the cross gable is pierced by a smaller multi-pane sash window. A narrow brick stack rises from the center of the house.

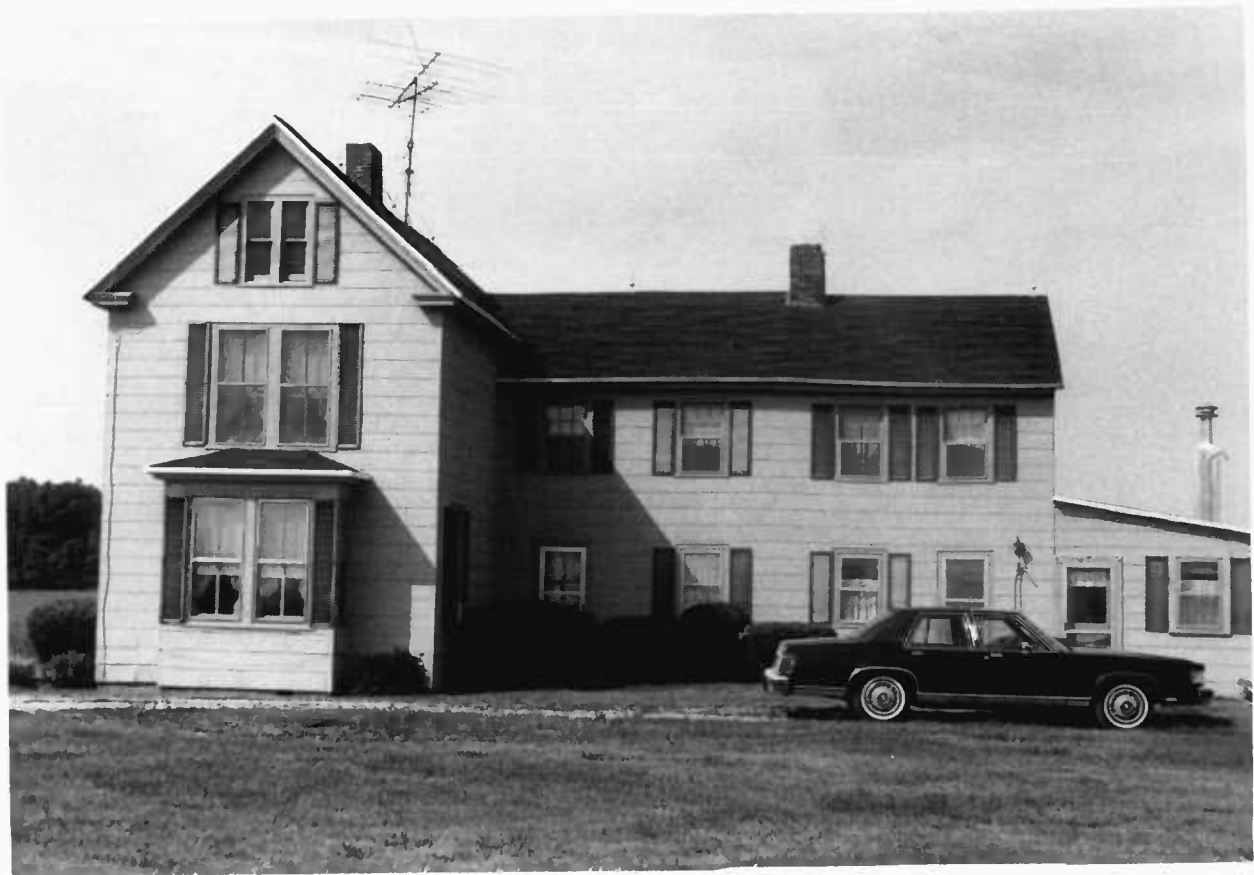
William Martin House                      S-354  
Princess Anne vicinity, Somerset Co., Md.  
South Elevation  
4/86, Paul Touart, Photographer  
Neg./Md. Historical Trust

The south gable end has a single-story bay window with paired two-over-two sash windows, and the second floor is also lighted by a pair of two-over-two sash. A pair of single-pane sash light the attic. The eaves to the roof are slightly extended and finished at the base of the roof with short returns.
